#### National Register of Historic Places Registration Form

1. Name of Property	
historic name West Denton Warehouse/Wharf	
other names CAR- 311	
2. Location	
street & number 10215 River Landing Road	not for publication
city or town West Denton	vicinity
state MD code MD County Carolin	e code011 zip code21629

#### DESCRIPTION SUMMARY:

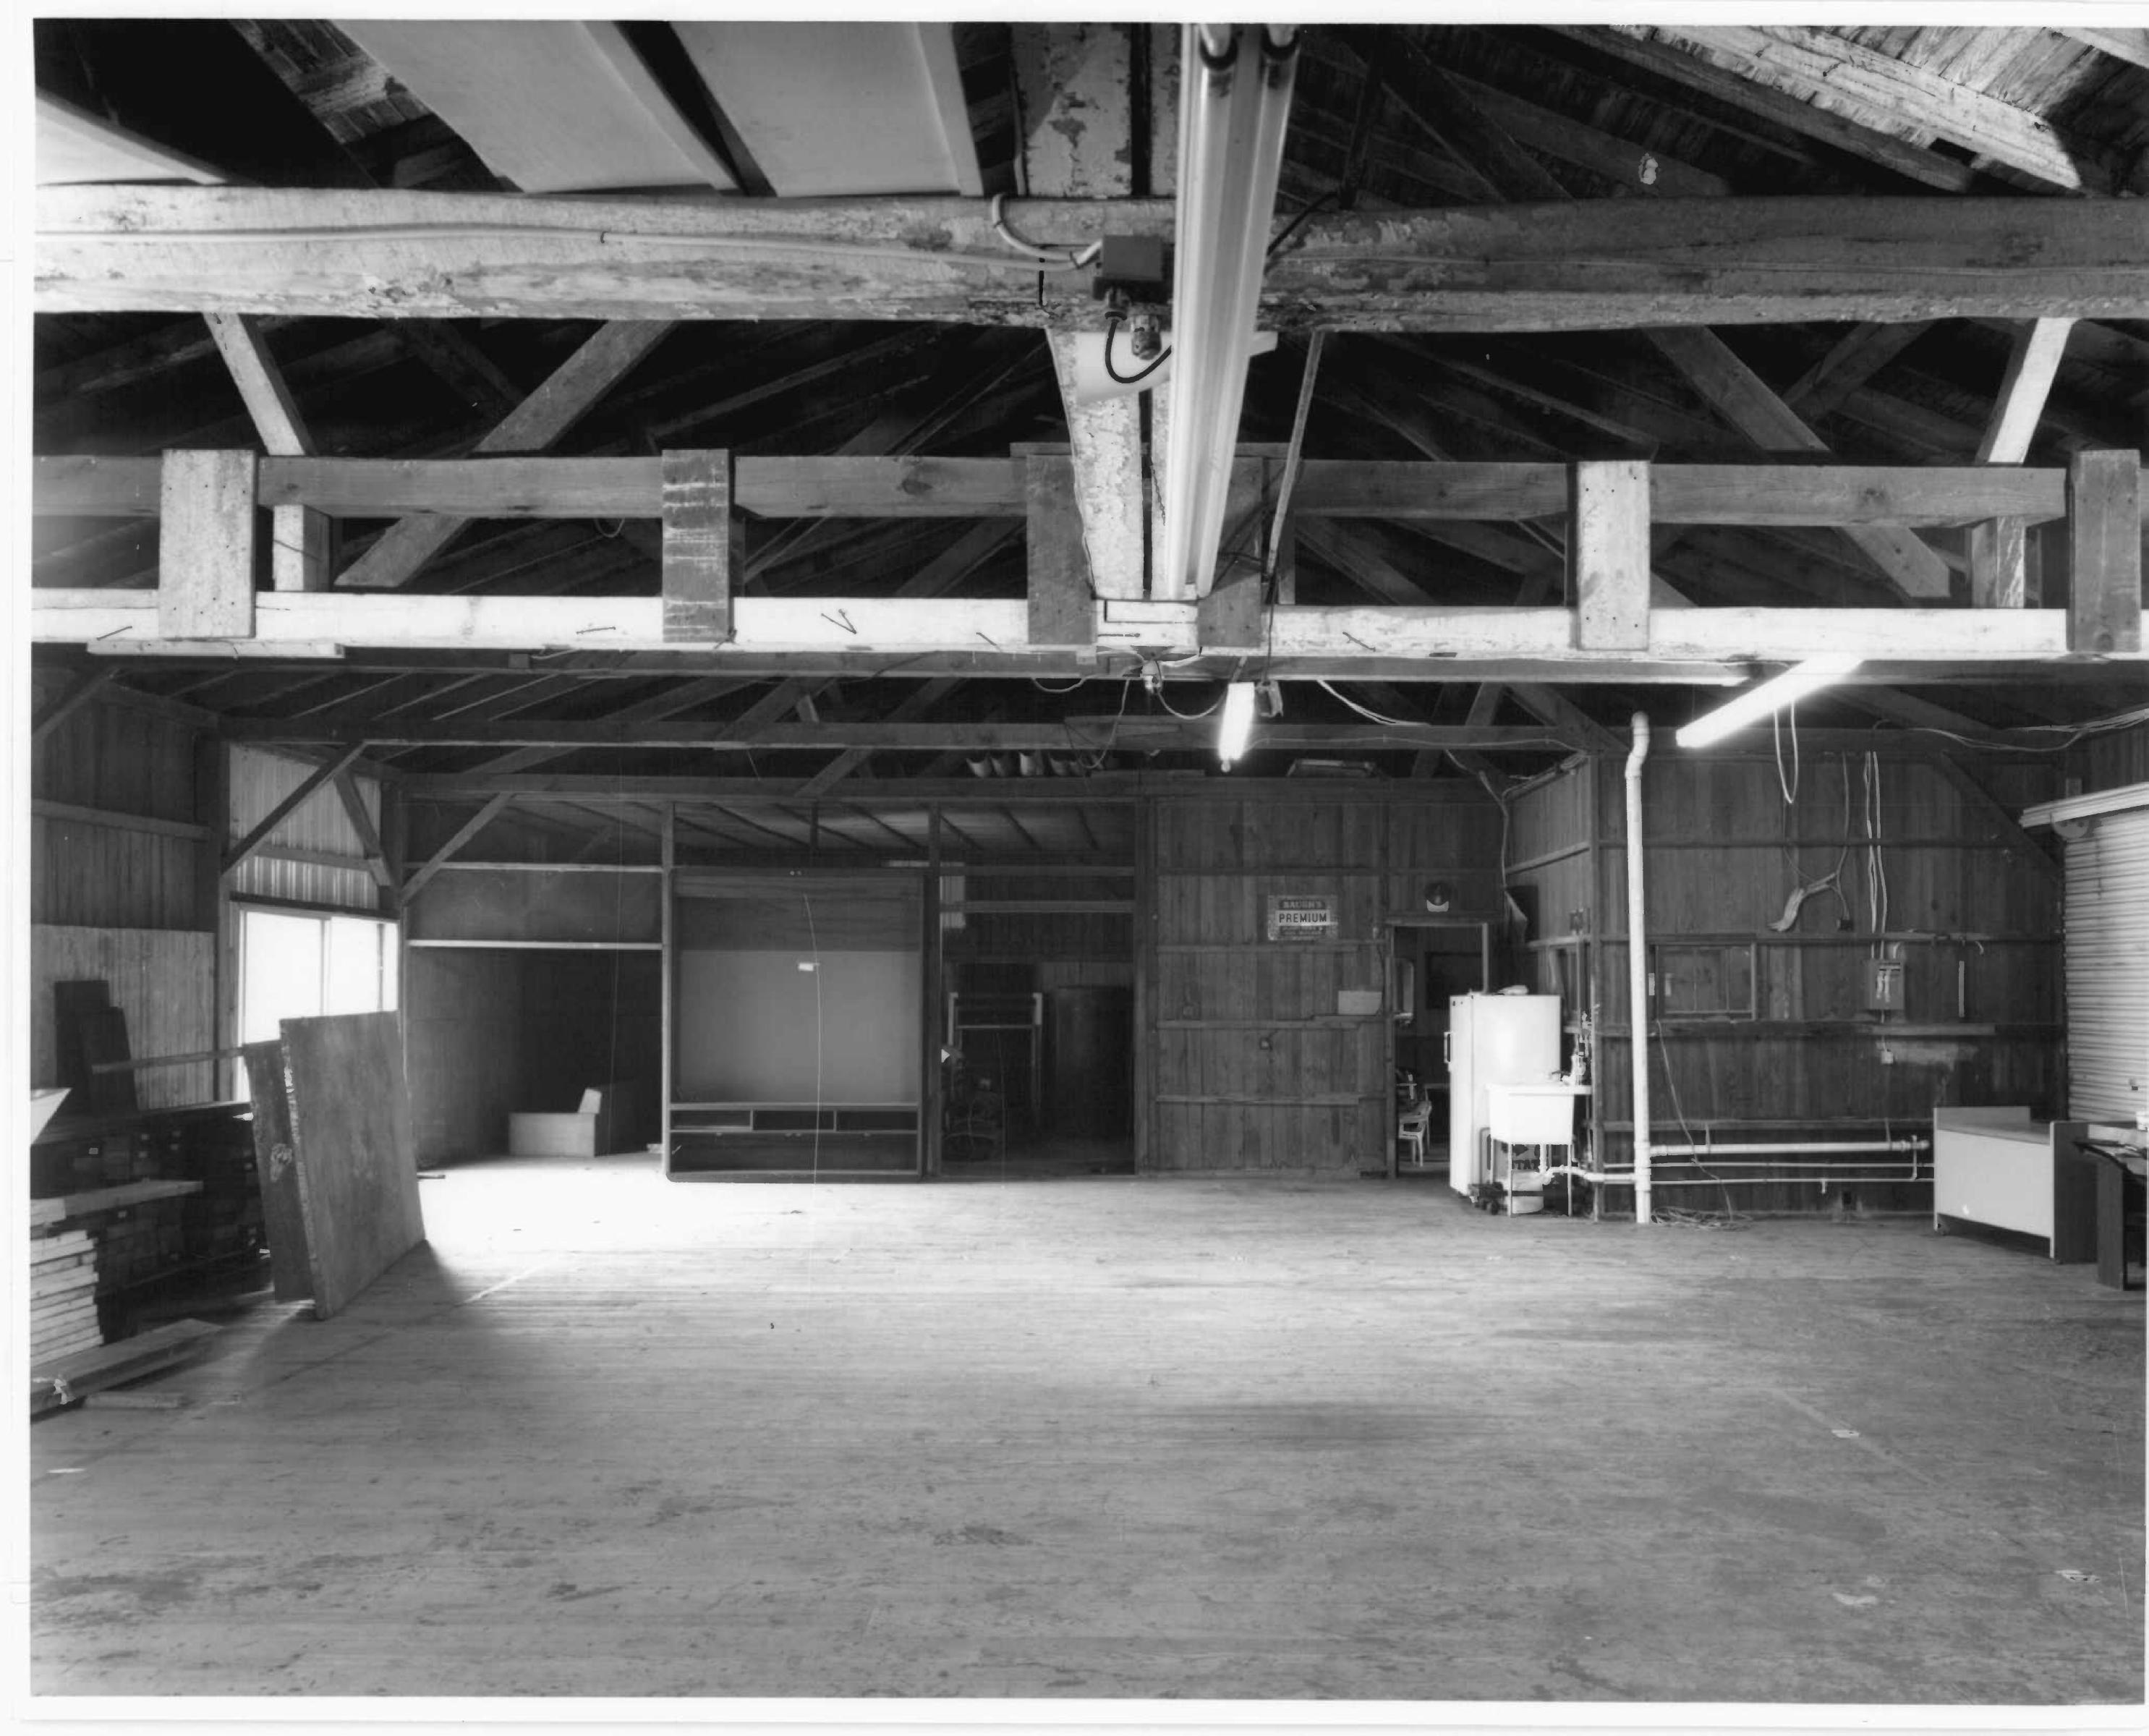
Description- Typ. section of warehouse, south end of etructure at transition from original bldg.

to addition. Photo taken from center of warehouse facing south.

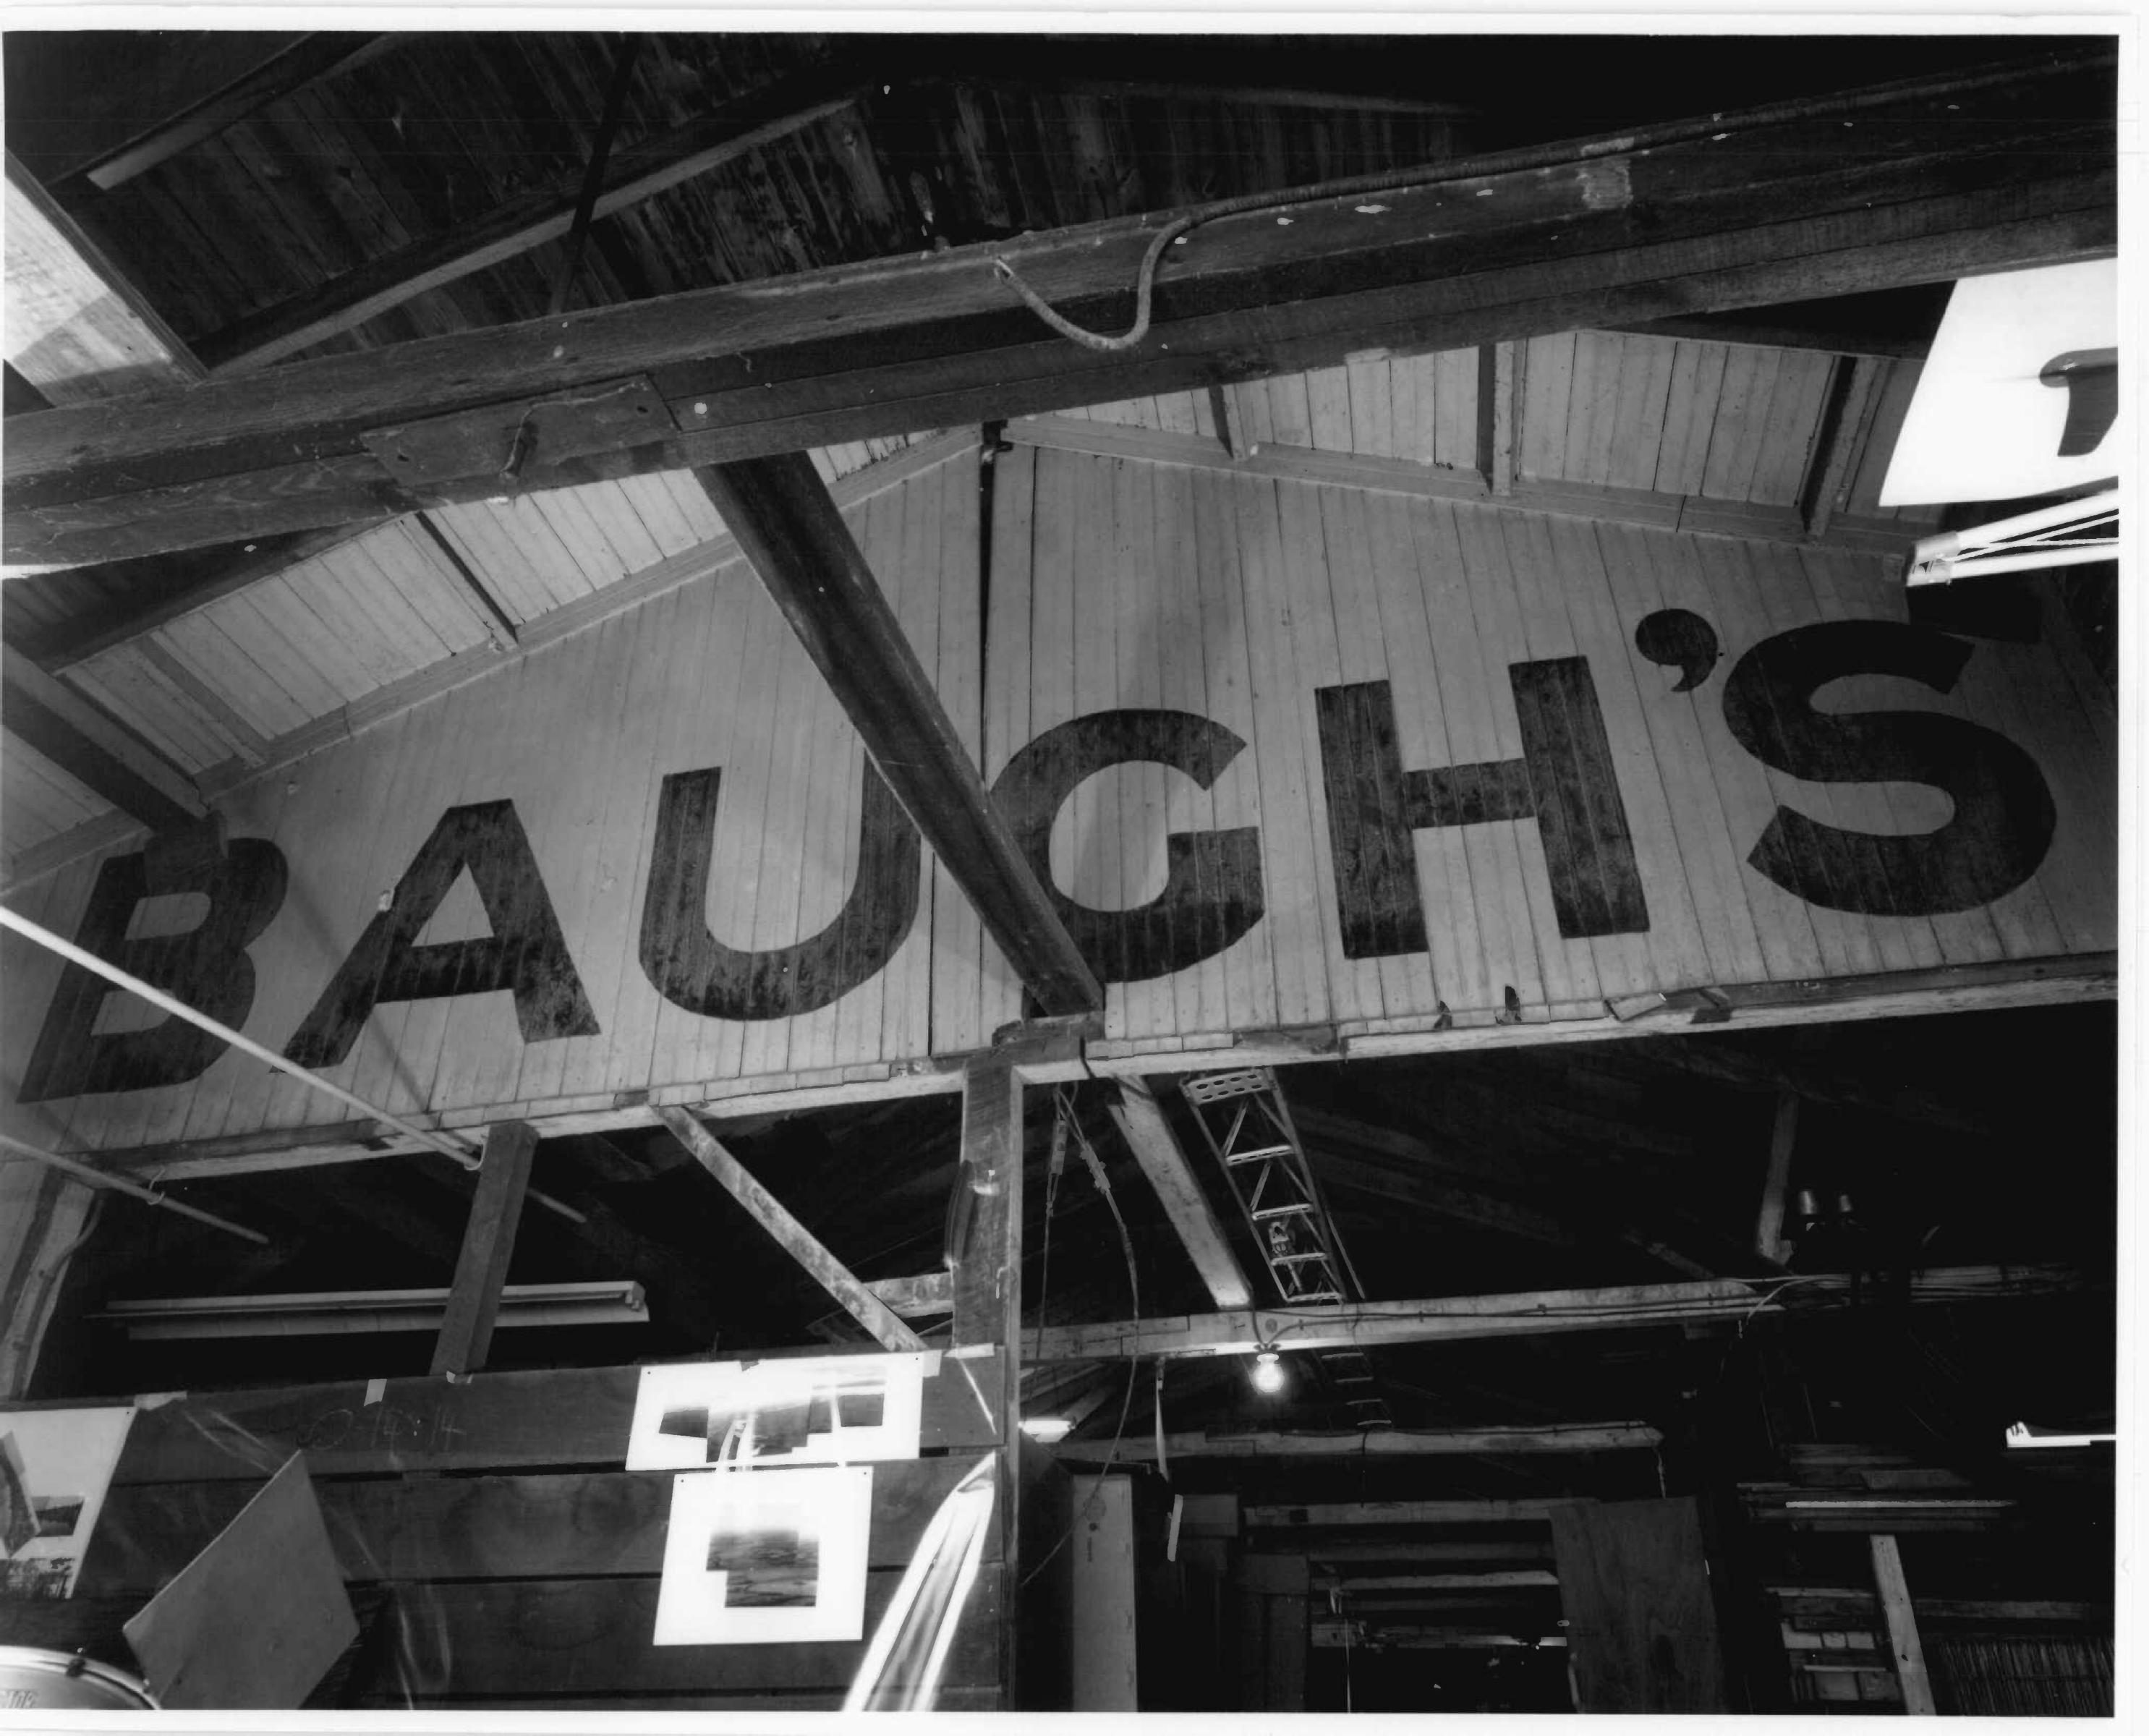
Description. Signage on north end of structure taken from the northend of the warehouse facing south. The "BAUGH'S" sign was on the north face of the bldg. exterior prior to the contruction of the additions.

Decorative elements - A unique decorative element of the structure is the hand painted sign on the north end of the original central portion of the warehouse which reads "BAUGH'S." The letters are painted in bold black on what was previously the exterior of the building. The Baugh Fertilizer Company owned the building in the 1930's.

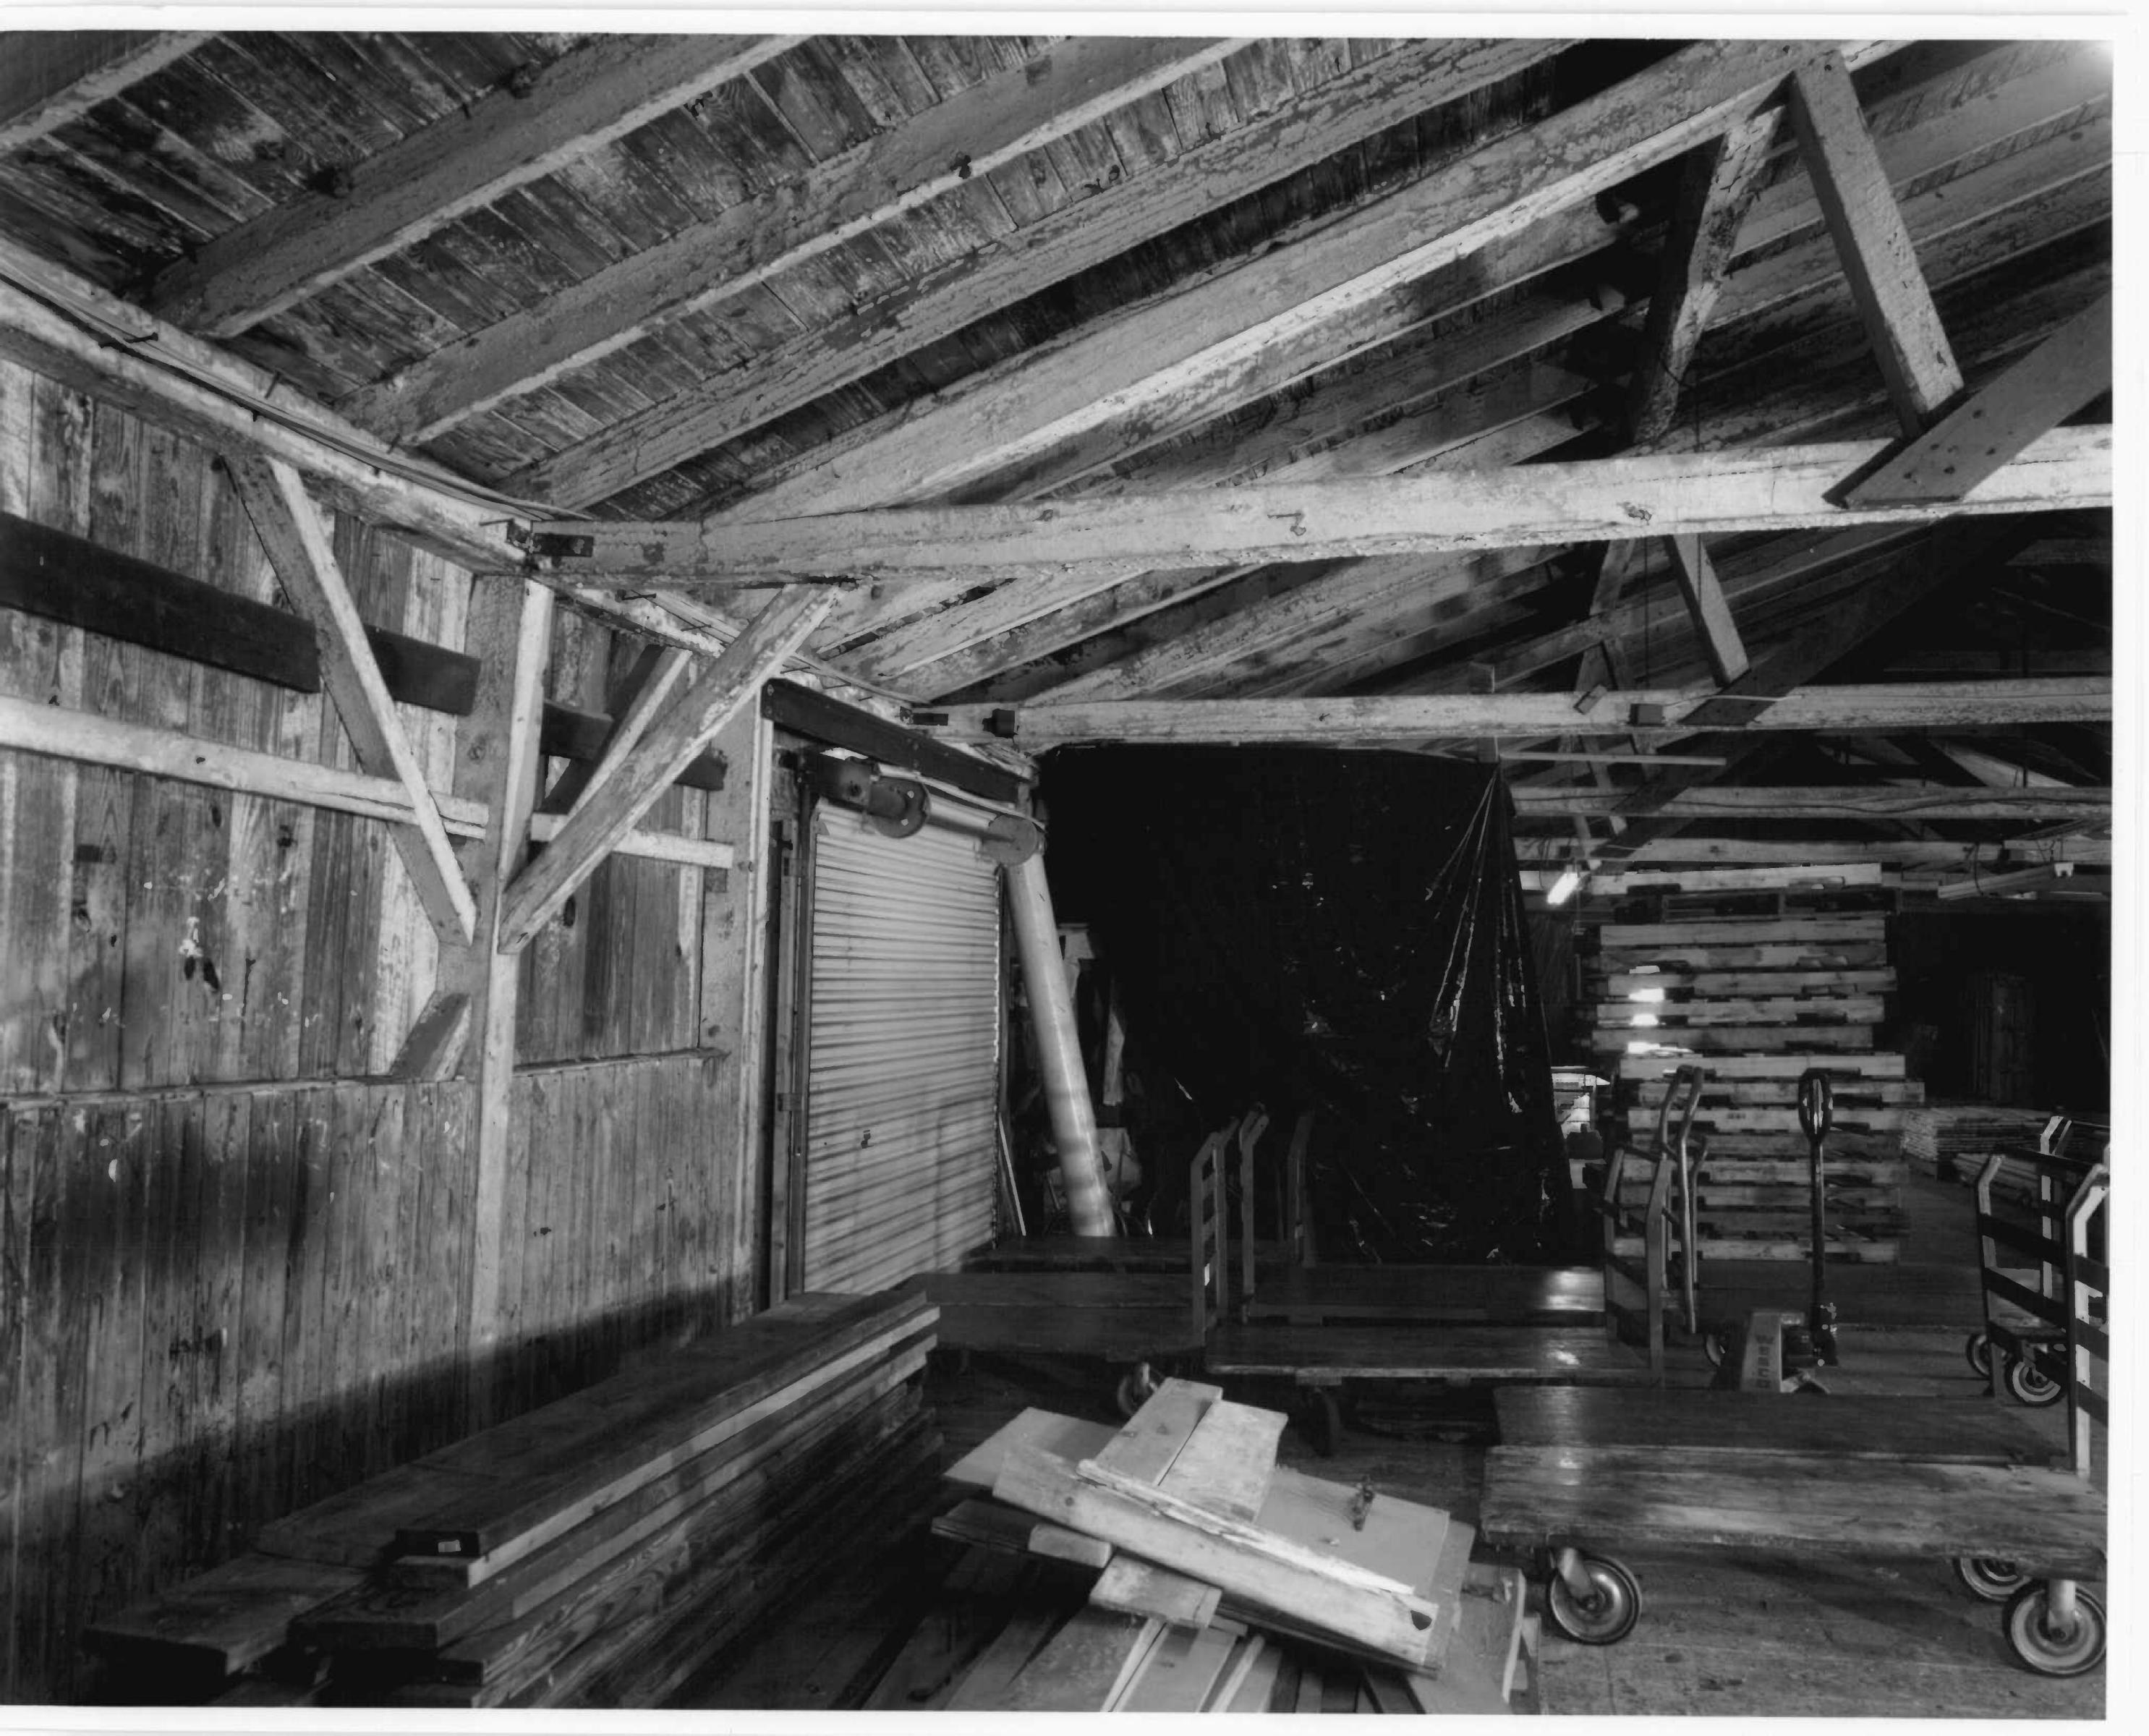
Description-Typ. interior wall section, original (center)

portion of warehouse, west wall. Photo
taken from south facing north.

Walls - The typical wall sections consist of heavy timber columns spaced at 10' o/c (coincidental with the trusses) braced with horizontal beams and diagonal knee bracing at the columns. The exterior wood siding is tongue-and-groove pine (6" wide wainscoting) that has been covered with corrugated steel panels. Where the original siding has been exposed it is buff in color and is typically in good condition. The interior wall finishes consist of the. exposed inside face of the exterior siding (for the top four feet) and four feet (bottom four feet of wall) of pine wainscoting attached directly to the horizontal beams that brace the columns.

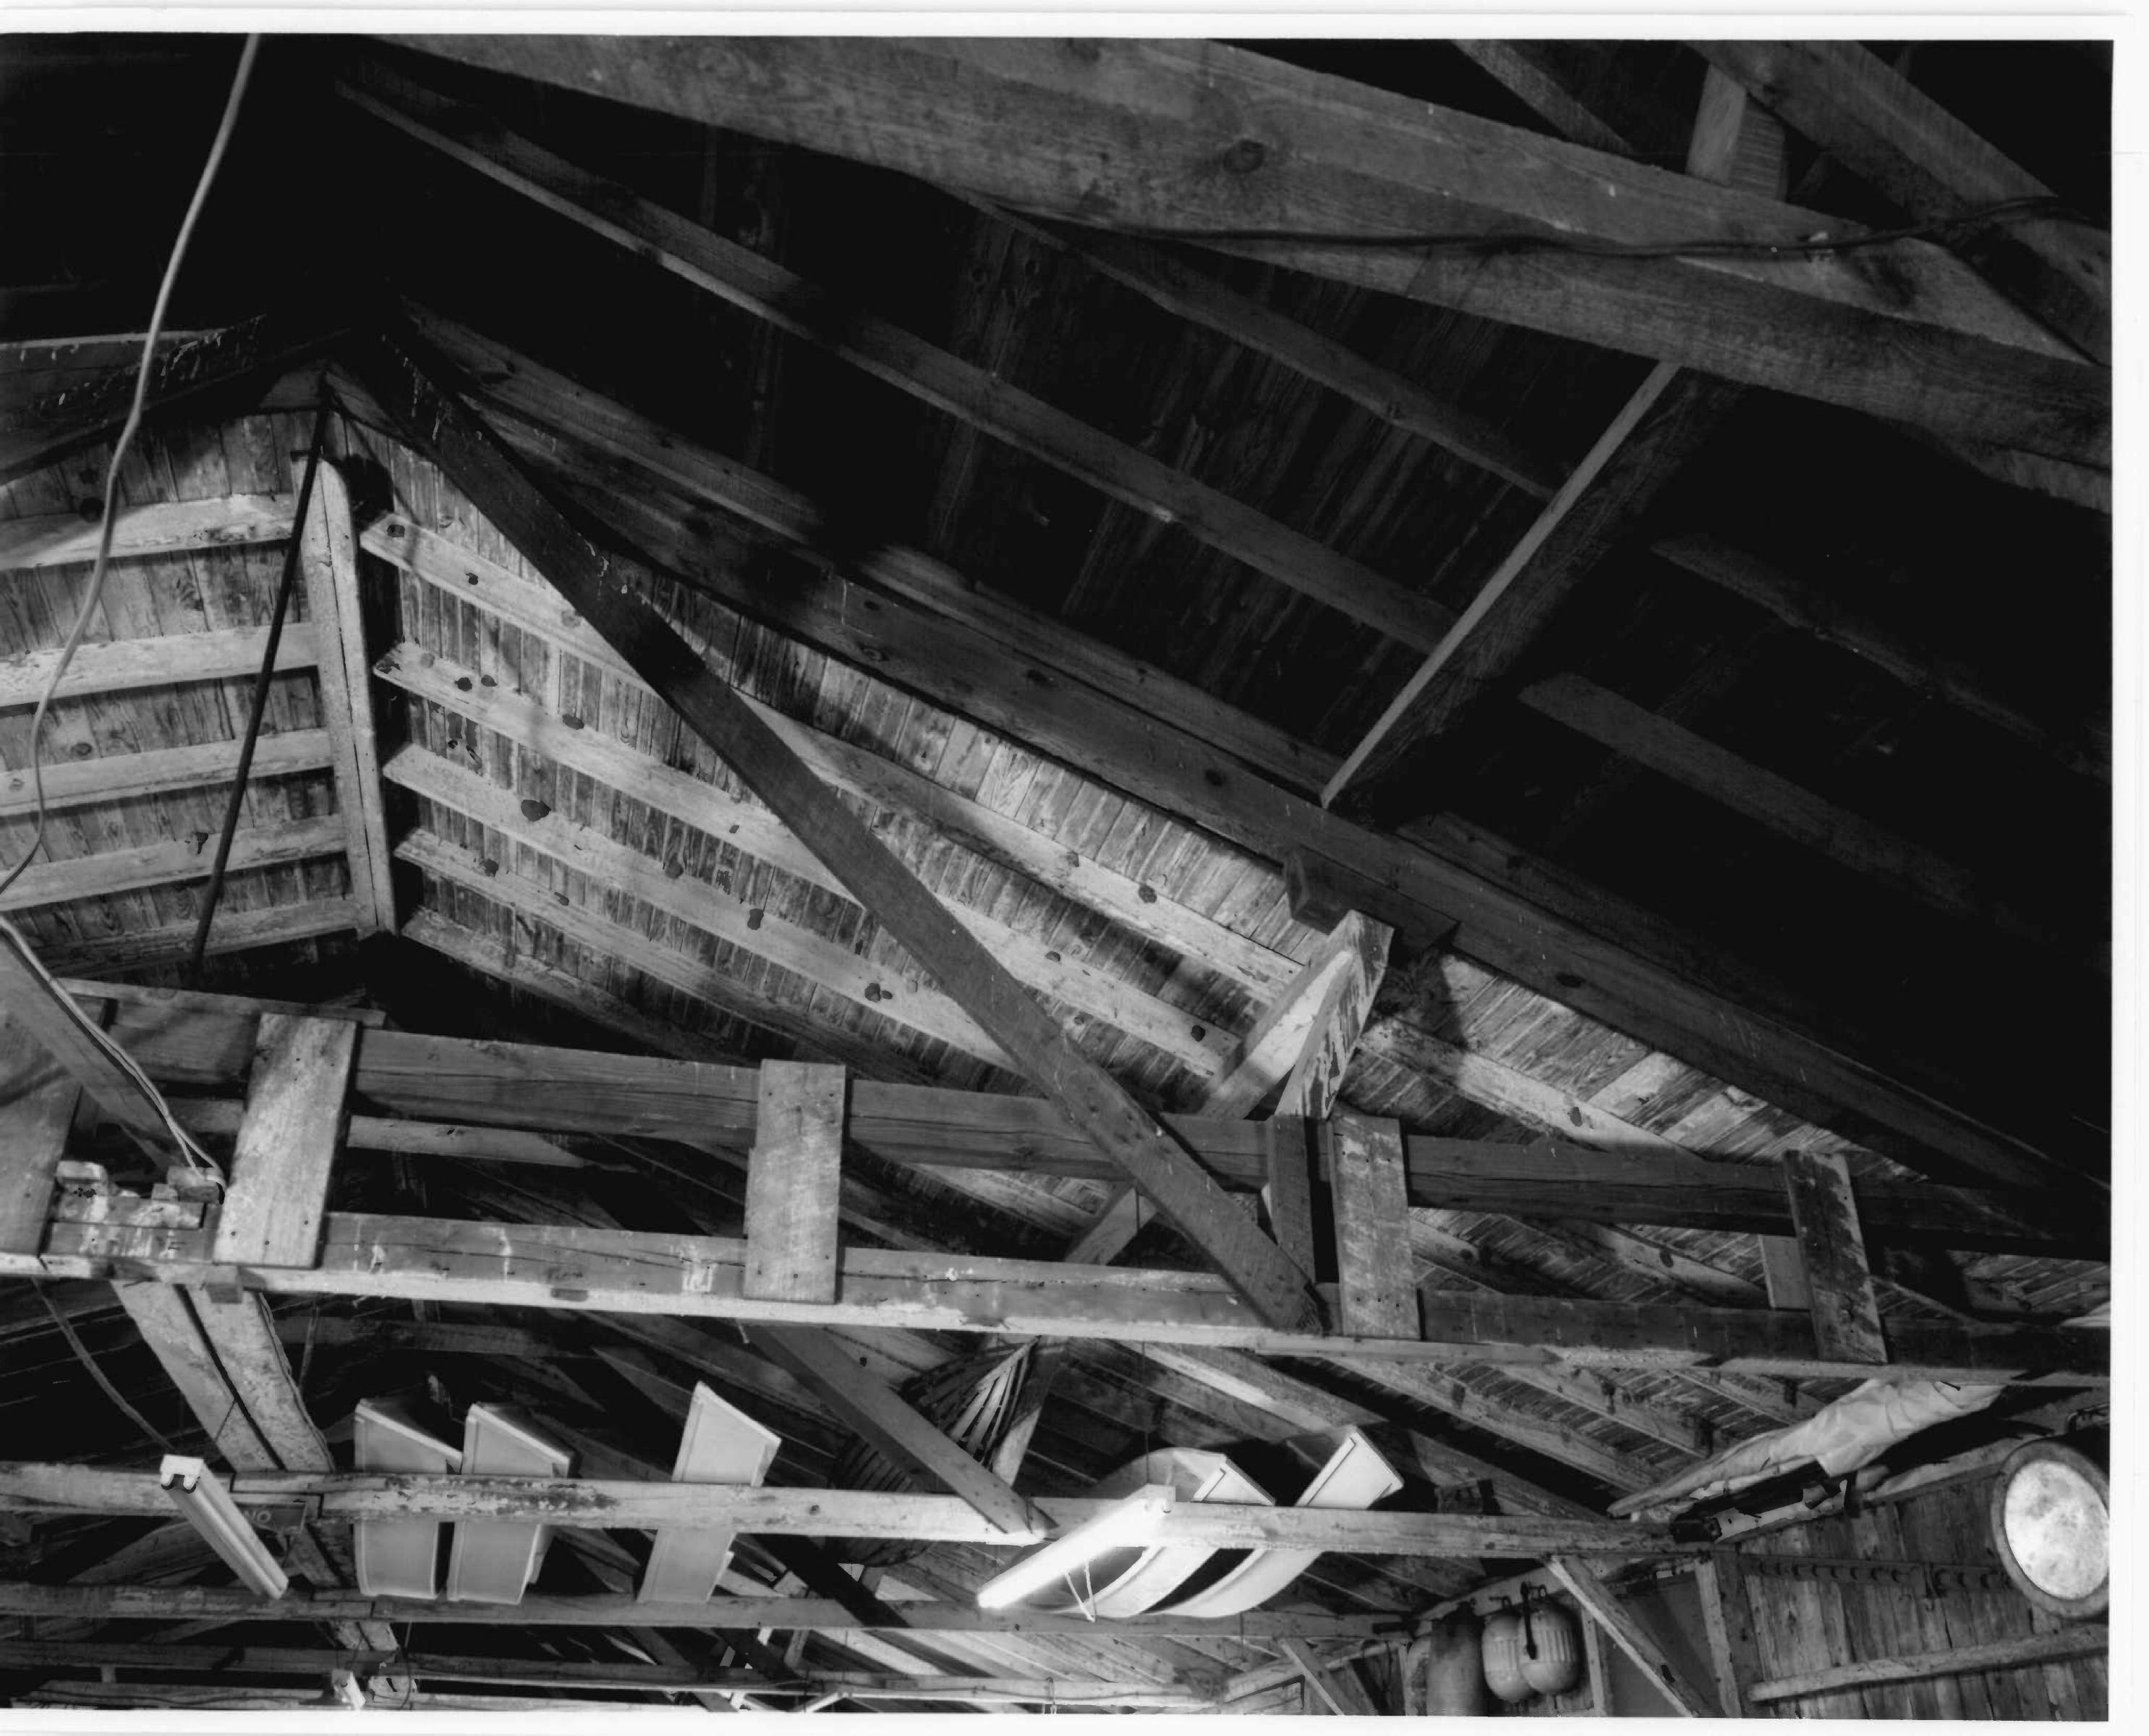
Description - Typ. half section of roof trussed transition from addition (southend) to original bldg. Photo taken from south end of warehouse facing north.

The roof construction consists of seventeen (17) forty-foot clear span timber trusses which are connected the wall columns at 10' a/c. The trusses are of similar construction in both the original structure and the additions. The truss construction consists of an A-frame configuration with a bottom chord which has a scarfed joint at the mid chord location. At this location a center tension iron rod picks up the load transferred to the bottom chord from the top chord (principal rafters) via diagonal braces (struts) located directly below the midpoint of the roof (common) rafters. This type of truss is referred to as a "king rod" truss in several carpentry

references.<sup>4</sup> At the midpoint of each top chord leg a 6" X 6" purlin spans between trusses and supports 2" X 6" roof rafters which are spaced 24" o/c and 24' long. The common rafters are supported at the end walls and at the midpoint of each principal rafter leg. There is no ridge beam in the older portion of the structure. The common rafters in the additions, however, bear against a 2" X 6" ridge beam. The roof is sheathed with tongue-and-groove pine and this sheathing is covered with asphalt impregnated roofing felt and clad with corrugated tin panels. The roof is a gabled roof with a 2/5 pitch (approx. 8' rise in 20'). The ridge line of the south addition is approximately two feet higher than the remaining ridge line.

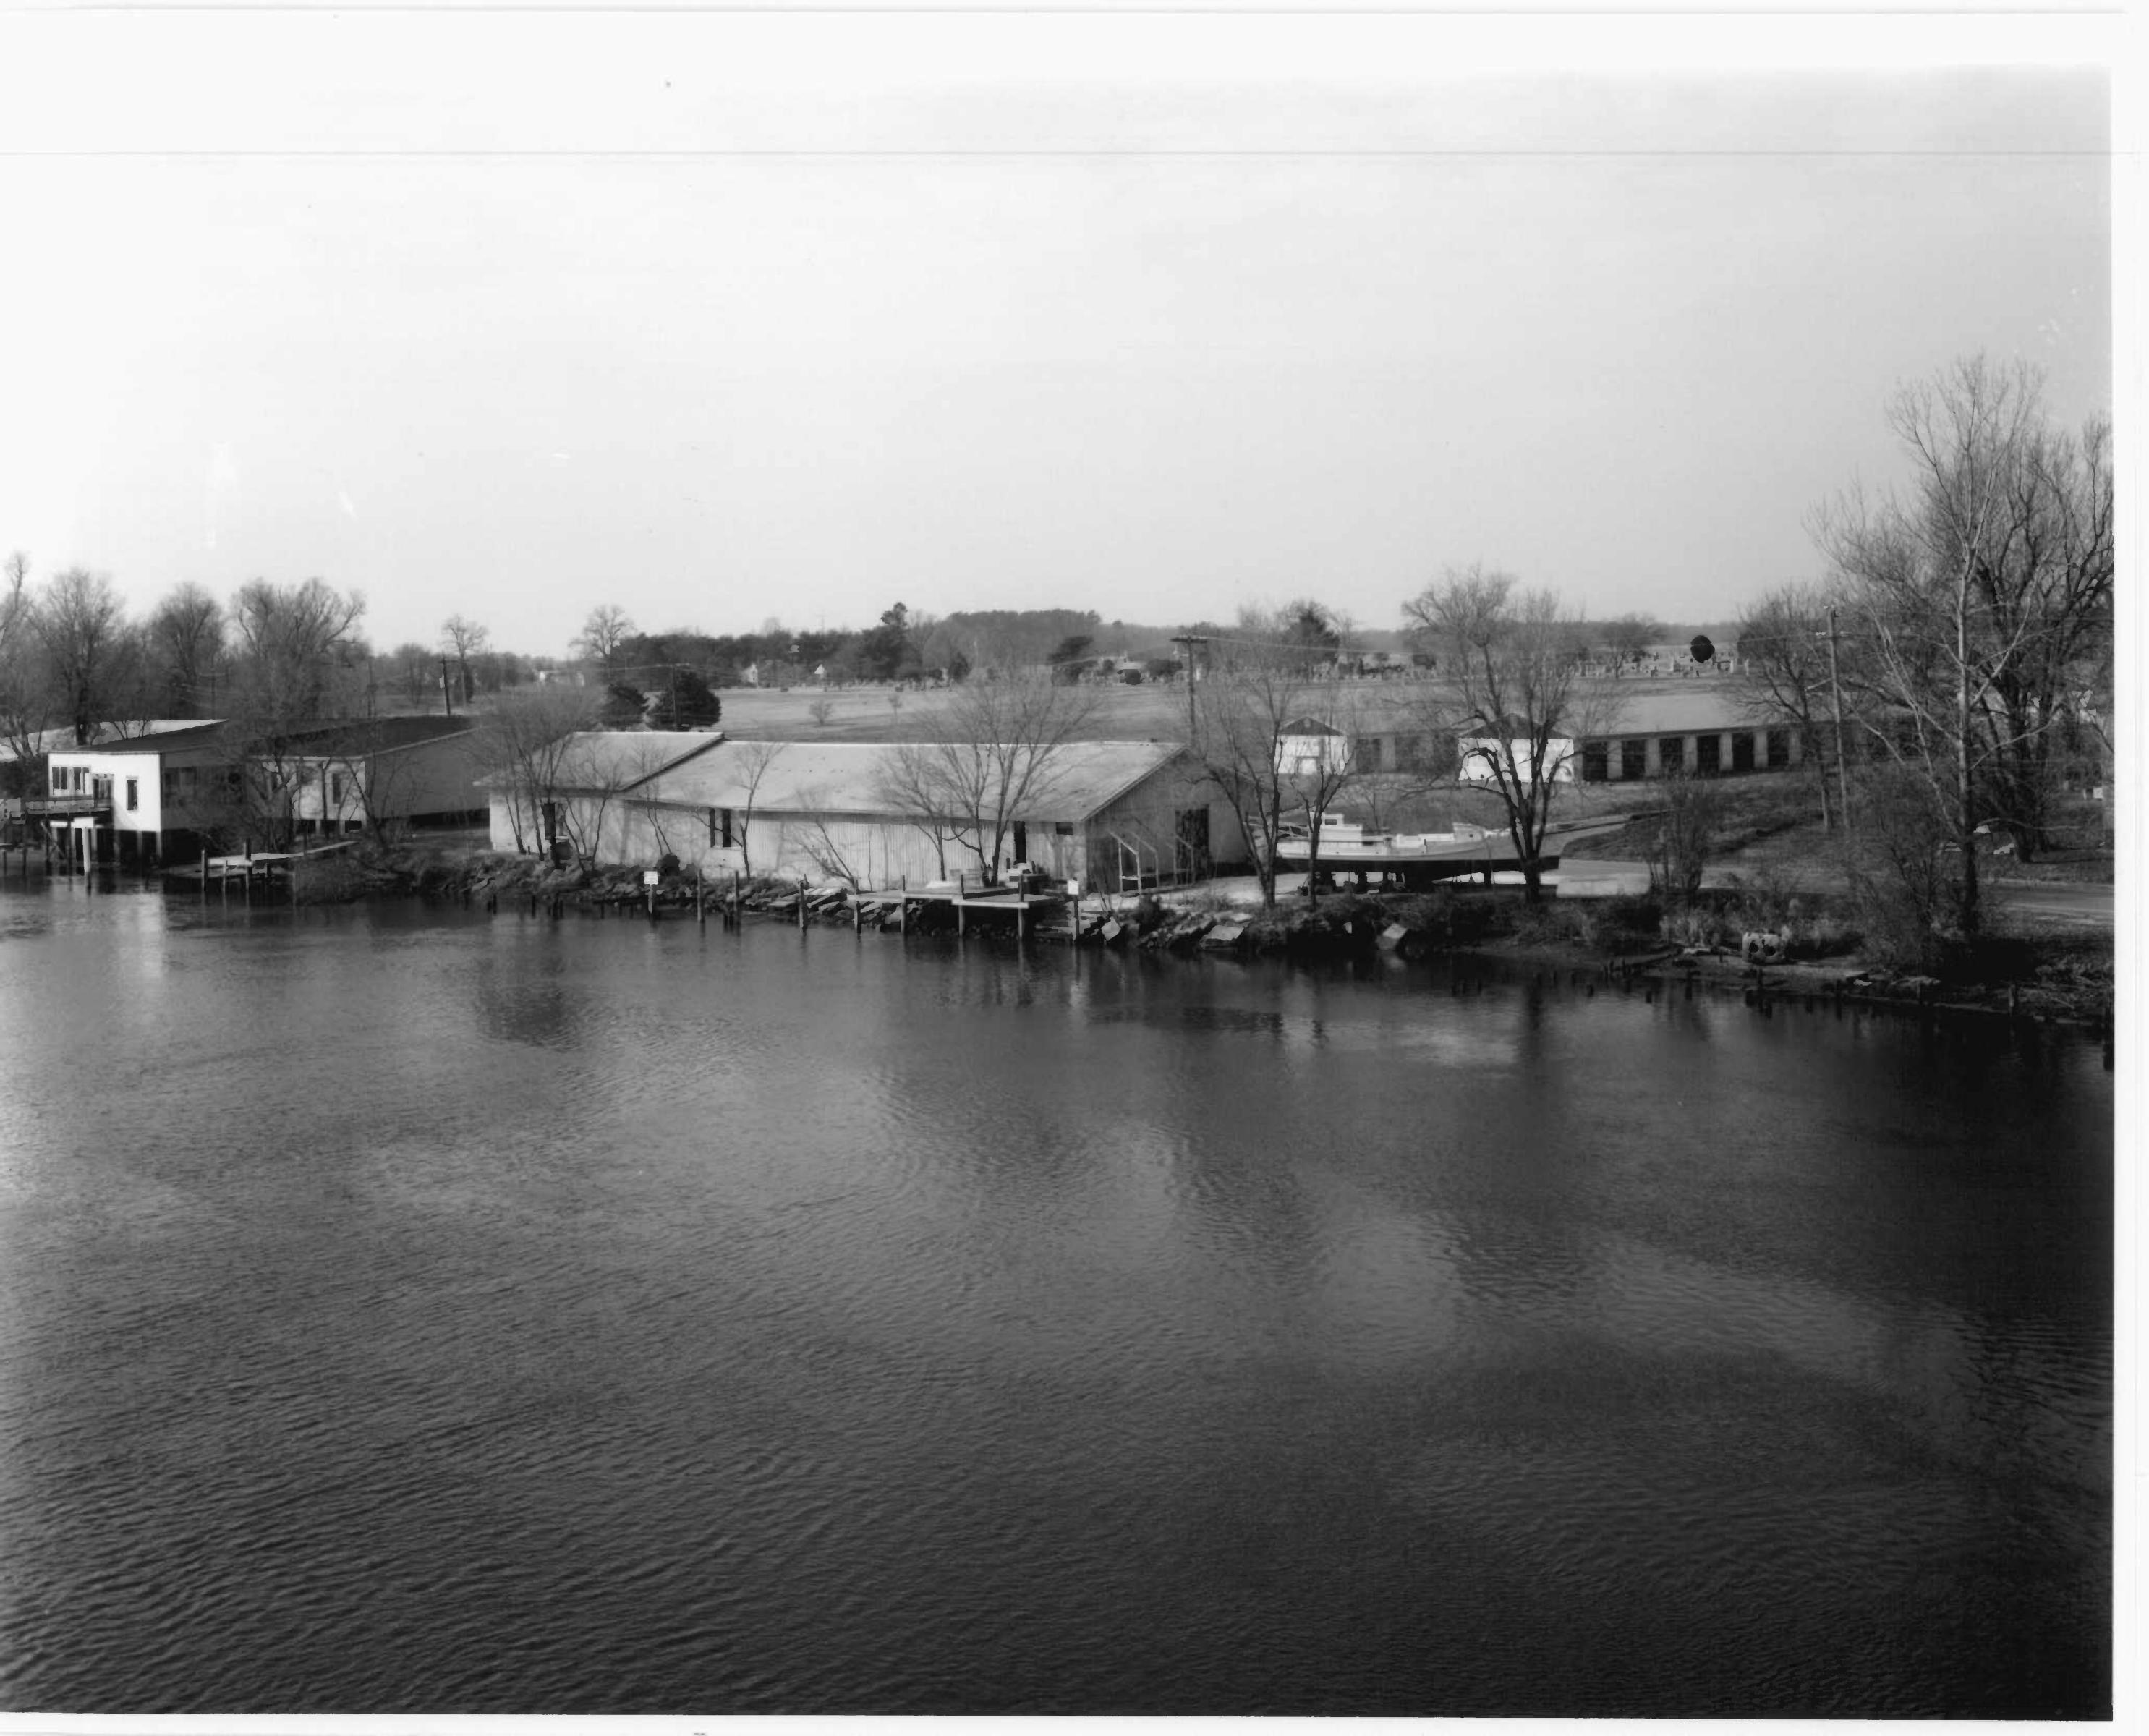
Description- East elevation taken from Md. Rt 404 bridge @ Denton. Choptank River in foreground, West Denton Cemetary in background.
